Applications for **Thermal** Imagers

## Moisture in building envelopes

### Application Note

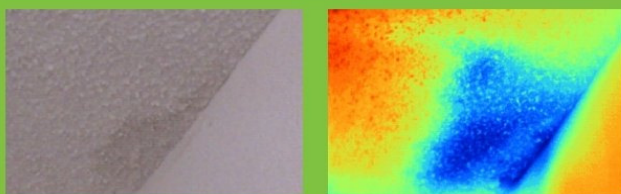
Unexpected moisture intrusion in a ceiling.

When potential wet spots in exterior walls and roofs are identified, follow up with an inspection inside the building, to further refine the outdoor findings. Inside inspections can also independently pinpoint moisture in ceilings and walls caused by leaks, water pipe breaks, fire-sprinkler discharges or other water-producing events. Fast action with a thermal imager following a water-producing accident can identify which materials must be dried or replaced.
